# Manhole Inspection Summary

Manhole # S51GG\_020MH

Insp Date: **6/9/08 8:40 AM**

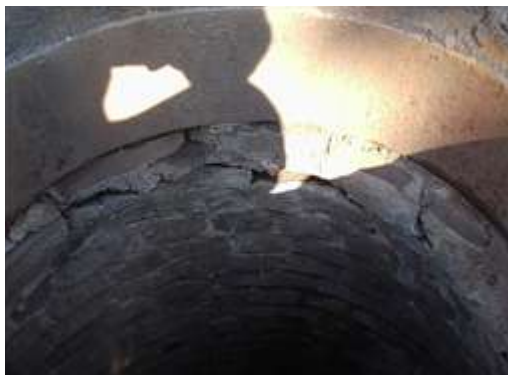
Defect 1

**Frame** Offset: **2** (in.) Condition: ☐ Sound ☐ Cracked ☒ **Leaks**

frame leaks

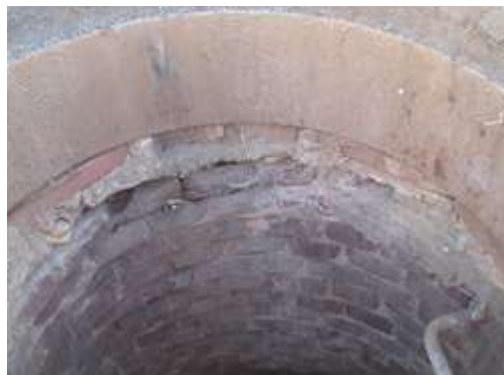
Defect 2

Condition: ☐ Sound ☐ Cracked ☐ Root Intrusion ☒ **Loose Brick** ☐ Deteriorated

Infiltration: ☐ None ☐ Joint ☐ Cracks ☒ **Mortar** ☐ Roots ☐ Wall

loose bricks

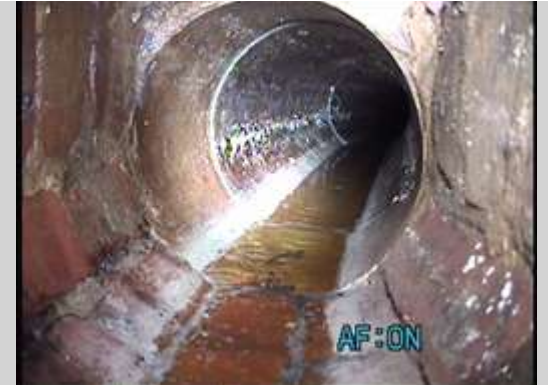
12 O'Clock Outflow

8 in. Circular Gravity Sewer  
Pipe Out @ 12 O'Clock

Pipe Height: **8.4** (in.) Rod and Bar (Angled)  
Pipe Material: **Clay** ☐ Pipe Lined  
Invert Depth: **11.60** (ft.) Flow Characteristics: **Fast**  
Deposits: ☒ None ☐ Mud ☐ Sludge ☐ Debris ☐ Grease  
Silt Depth: (in.) Deposits Extent:  
Infiltration: **None** Pipe Seal Cond: **Sound**

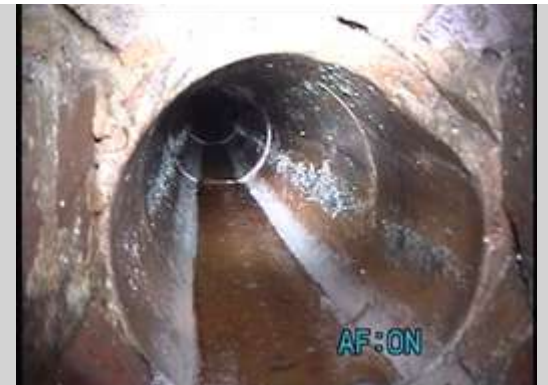
3 O'Clock Inflow

8 in. Circular Gravity Sewer  
Pipe In @ 3 O'Clock

Pipe Height: **8.4** (in.) Rod and Bar (Angled)  
Pipe Material: **Clay** ☐ Pipe Lined  
Invert Depth: **11.55** (ft.) Flow Characteristics: **Fast**  
Deposits: ☒ None ☐ Mud ☐ Sludge ☐ Debris ☐ Grease  
Silt Depth: (in.) Deposits Extent:  
Infiltration: **None** Pipe Seal Cond: **Sound**
